# Under Sandy Boulevard

## Value Engineering Trenchless Solution for Rehabilitation of Trunk Sewer in Portland

Fahim Rahman, P.E.

City of Portland Engineering  
Services, Portland, OR

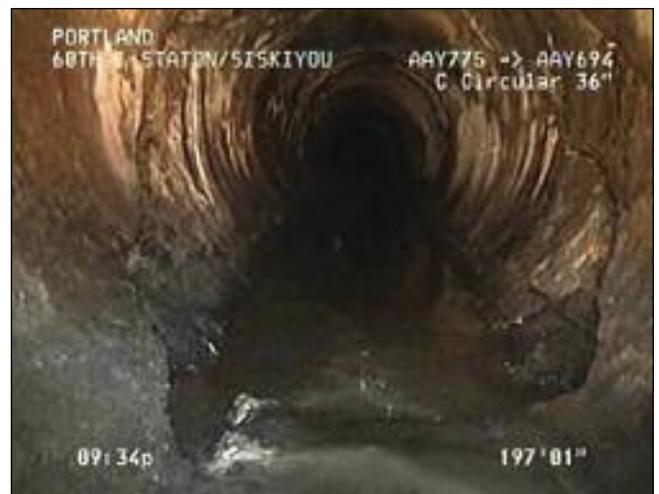
In June 2008, a video inspection was made of Halsey Combined Trunk Sewer in northeast Portland, Oregon. This trunk sewer runs approximately 35 feet beneath NE 60th Avenue and passes underneath Sandy Boulevard, a busy arterial. The video inspection revealed longitudinal cracks in the pipe at 10, 12 and 2 o'clock throughout the entire length from Klickitat Street down to Brazee Street, with ovality of 10-25% in some areas. NE 60th Avenue is only 23 feet wide curb-to-curb; therefore, open-cut replacement was not an acceptable option. The other problem with the trunk sewer was its existing lateral connections to the surrounding properties, made through deep vertical risers. Most of these deep vertical connection risers were found to have settled and dropped into the trunk sewer.

*Existing deteriorated 36-inch sewer pipe*

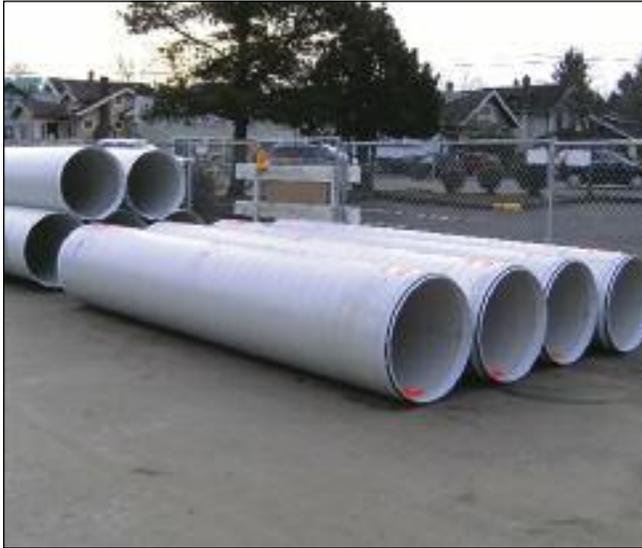
*31-inch ID PVC Vylon pipe*

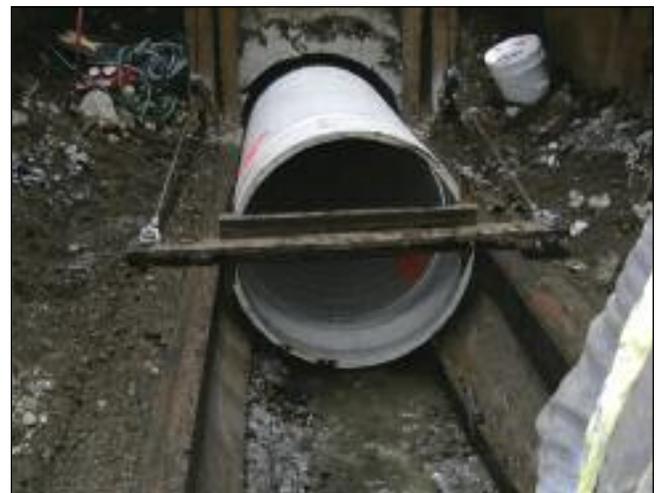
*PVC Vylon pipe being installed*

Preparation for sliplining commenced with the installation of five 35-foot-deep shafts using engineered slide rail-shoring. Before any actual sliplining began, a tapered steel pipe of 32-inch OD was pulled from Stanton Street to Brazee Street as a pilot to check for any obstacles within the existing pipe. The pilot reached the shaft at Brazee without any problems, and 1,000 feet of Vylon PVC pipe was installed in live flow in just two days.
