Vylon Pipe

Sinkholes, Sinkholes Everywhere

By: Ken Glasgow,
Gulf Coast Regional Manager

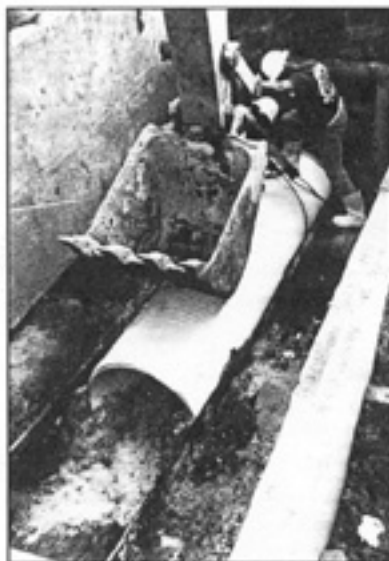
Backhoe bucket maintains control of new joint prior to assembly. Contractor poured concrete mats for work area floor safety and to keep dirt out of the line.
