Sliplining Saves Sewers in New Jersey

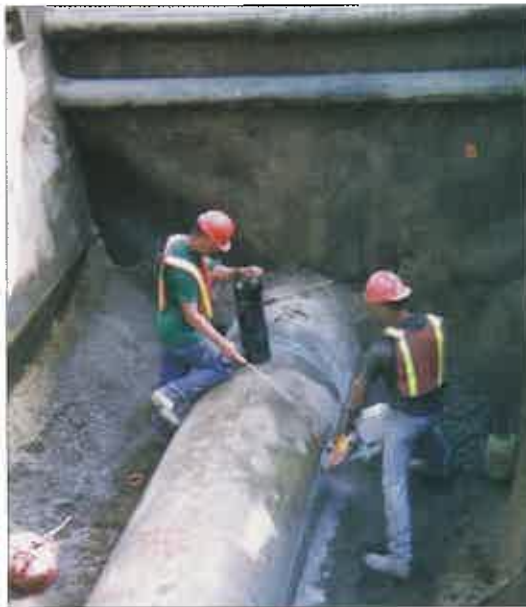
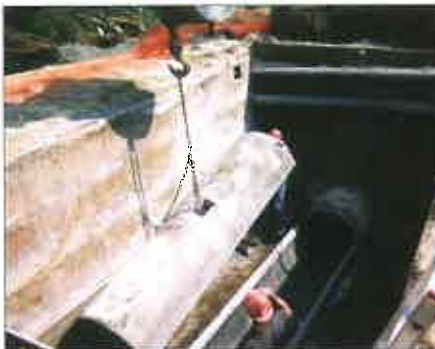
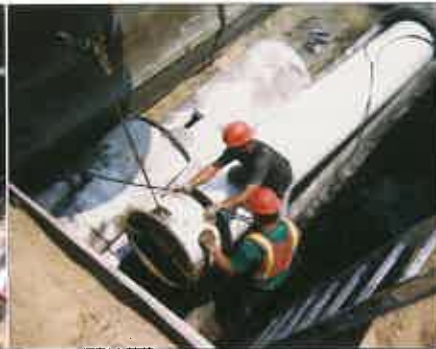
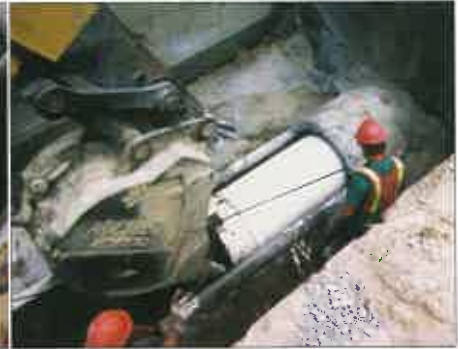
Metra Industries/Spiniello used Lamson Vylon PVC Slipliner to restore 2,400 ft of 36-in. ID concrete pipe in Ocean County, N.J.

Once exposed, crews removed the crown of the pipe so that the slipliner can be lowered into the pipeline. Typically, a backhoe is used to excavate the pit, lower the slipliner into position in the host pipe and then push it into place. The Vylon slipliner is equipped with a locking feature so that each pipe segment snaps together. Bulkheads are also constructed at each end to constrain the pipe. Once the pipe is sliplined, the annulus is filled with a lightweight grout.
